TOWN OF SMITHFIELD, VIRGINIA REQUEST FOR PROPOSALS

FOR USE AND LEASE/SALE OF REAL PROPERTY

HISTORIC WINDSOR CASTLE FARM

SUBDIVISION
OF THE PROPERTY OF
WINDSOR CASTLE, LLC
BEING TAX PARCELS
21-01-092 & 21-01-089A
WINDSOR CASTLE
TOWN OF SMITHFIELD, VA
SCALE: 1"=300' DATE: 02-16-09

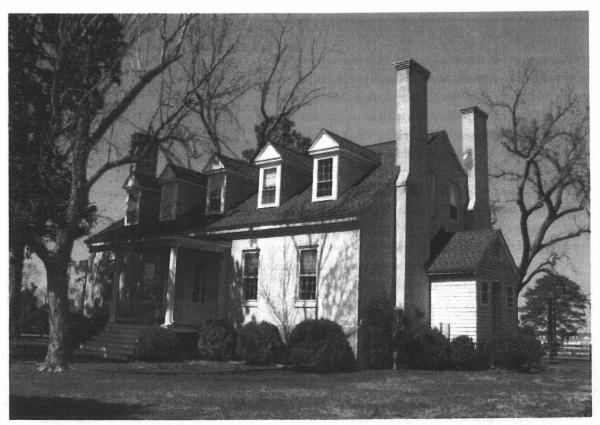
Figure 1.2 The southwest elevation of the house has a hipped-roof portico and five dormers and is the less elaborate entry to the house.

The core of the house, measuring approximately 57' by 40', is a gable ended, one and a half story, stuccoed masonry dwelling on a slightly raised basement with a beveled watertable. Two semi-exterior end chimneys with corbelled caps are found on the northwest and southeast elevations, as are modest later frame additions. The northwest and southeast elevations have paired nineover-six sash between the chimney stacks on the second story. The southeast frame addition is a single-story gable roofed side entrance that has incorporated earlier windows into doors to the frame vestibule. The northwest frame addition is offset to the north revealing paired nine-over-nine sash windows set below the nine-over-sixes above. This addition, which contains a modern kitchen, is slightly larger than that on the southeast, which pre-dates it. Both the northeast and southwest elevations have central double leaf entrances flanked by 2 nine-over-nine double-hung sash windows with nine-over-six windows in the dormers above and fixed windows in the basement below. The southwest elevation, which faces the current vehicular entrance to the property (from Jericho Lane), is the more modest of the two major entrances. The door itself is deep set and has a fixed transom divided into diamond panes above. The entrance porch is one-story and single bay with an extremely shallow half hip roof, which meets the house below the cornice at the eaves. The porch rests on two Tuscan columns and two squared pilasters, which have a simple rail with square balusters between. The porch deck is wooden and rests on stuccoed masonry piers with full-width wooden stairs leading to a short allee of boxwoods.

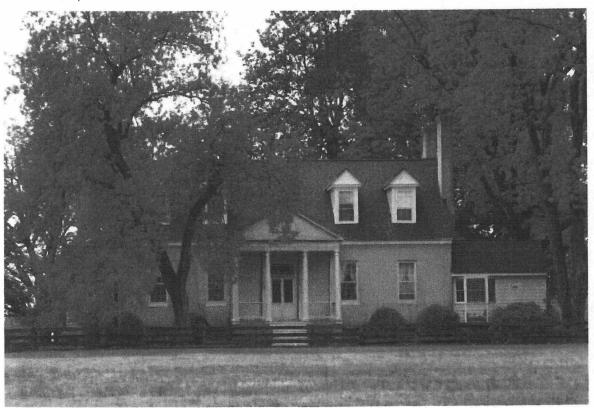
Figure 1.3 A Tuscan-columned portico accents the primary entrance to the house, which faces the water.

The northeast elevation has a central entrance portico resting on four Tuscan columns and four squared pilasters. The railing and balusters are similar to those on the southwest porch and are found between the pilasters and outboard columns and between the outer pairs of columns thus the corresponding wooden stairs from the wooden porch deck to the ground are not full width. As with the southwest porch, the northeast porch rests on masonry piers. The northeast porch has a pedimented portico which fades into the central roof as a cross gable, though below the ridgeline. Thus the northeast elevation has only four dormers, which align with the windows below (the southwest elevation has five dormers, one over each corresponding window and one over the central entrance), the portico roof extending into the area where a fifth dormer would reasonably be placed. The northeast entrance mirrors the southwest with a double leaf door and a fixed transom divided into diamond panes.

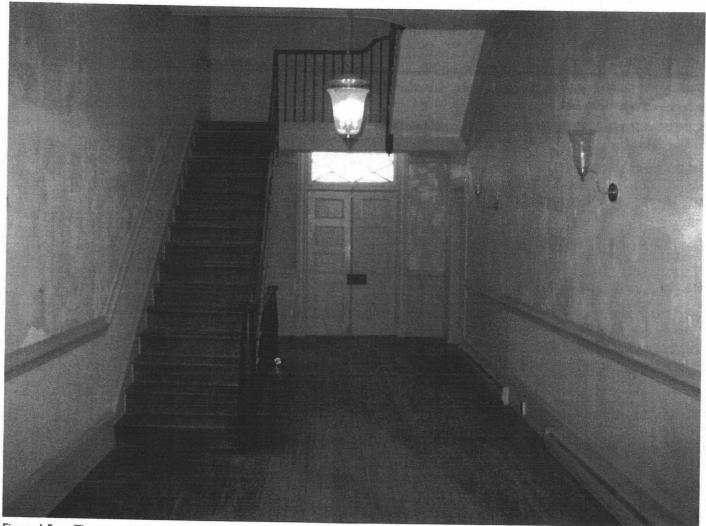
Figure 1.5 The central hall plan is typical of late-eighteenth and early-nineteenth-century Virginia tidewater architecture.

The first floor boasts a broad central hall measuring roughly 11' x 38' with an attractive dogleg stair which rises along the southeast wall of the hall to a landing the width of the hall then continuing a short flight along the northwest wall of the hall to the second floor. The simple rounded newel is the terminus for an equally simple and elegant rounded rail which ramps at either end of the landing (where it makes 90 degree turns) and again at the second floor where the rail turns broadly with a gentle curve. The balusters are square pickets. The rail and balusters are repeated in a short section below the stair, dividing the hall from a stairwell to the basement.

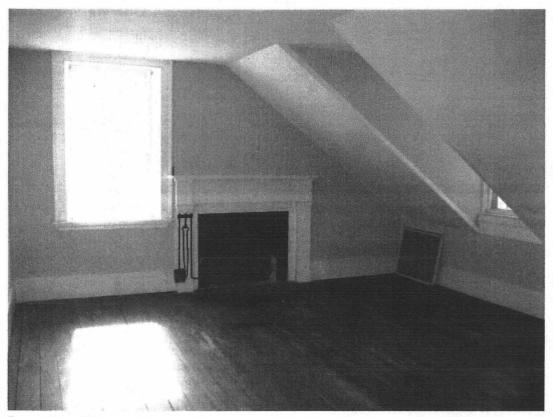
Figure 1.6 Finishes on the second floor are less detailed than those found on the first level.

The second story rooms, arranged in a similar plan as the first, are more modest scale with a lower ceiling height (9') and incorporating the roof slope in the northeast and southwest sides. The rooms are also more modest in trim, although the door frames and mantles are also Greek Revival, and appear to be from the circa 1840 remodeling. The door frames lack the corner blocks and more sophisticated detailing of the first floor and there is none of the later twentieth century crown molding or chair rail (save the chair rail which ascends with the stair up to the second floor level). The second floor's six-panel doors appear to date from the eighteenth century, however their style and apparent weathering is inconsistent with their frames. They may have been saved from an earlier incarnation of this house or salvaged from another property. The plan mirrors that below with the addition of a bathroom in the northeast room.

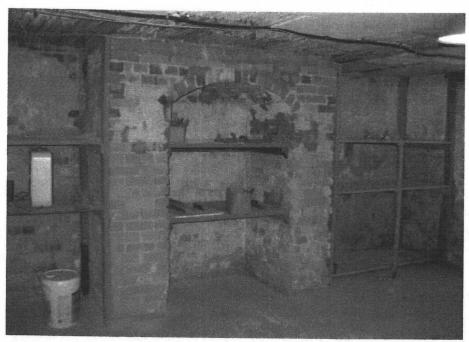
Figure 1.7 This brick arch once supported an interior chimney. The current chimneys are placed on the exterior of the house.

The southeast basement room has walls constructed of English bond, an interior wall window, an arched support for an interior chimney, and a now blocked entrance to the building's exterior.

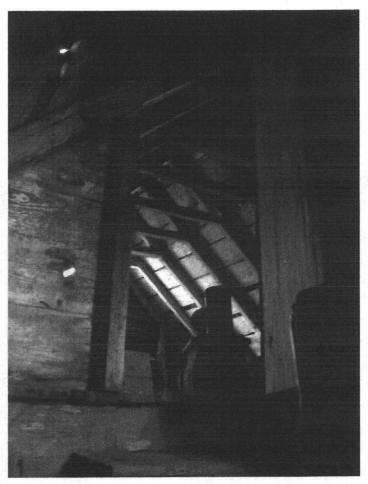
Figure 1.11 Early saw marks and joinery techniques are found in the attic and provide evidence to support the mid-eighteenth-century date of construction.

Some additional argument for an eighteenth-century construction date for the house is the mill saw marks in the roof framing. Unfortunately, the dormer framing is not visible nor are most of the second floor ceiling joists. Roof timbers are joined and pegged with no ridge board and some charred members at the ridge suggest a chimney fire – perhaps one that prompted the circa 1840 remodeling.

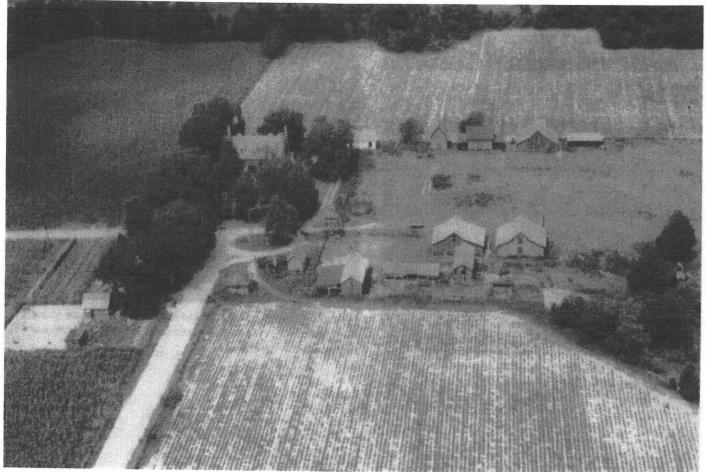
Figure 1.12 This undated mid-twentieth century aerial shows the house, outbuildings and surrounding fields. It also documents some no longer extant outbuildings.

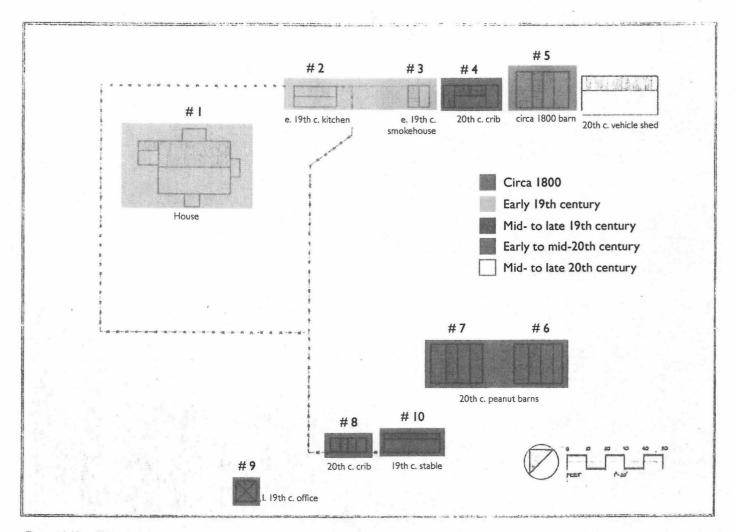
Figure 1.13 This sketch map, completed by a team from Colonial Williamsburg, shows conjectural approximate construction dates of the house and outbuildings and may be used to develop graphics on the agricultural development of the site.

The outbuildings noted by Colonial Williamsburg and illustrated on the following page are referred to using slightly different terminology and dating than found in the National Register nomination text. The Colonial Williamsburg names are included in parentheses on this page with outbuilding numbers keyed to the site map. We have chosen to use the Colonial Williamsburg terminology and dates for labeling of the site map and photographs.

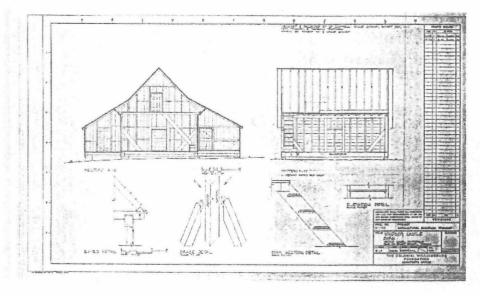
Figure 1.14 One of the farm's barns (circa 1800 barn, #5) was documented for Colonial Williamsburg's Agricultural Buildings Project in 1981.

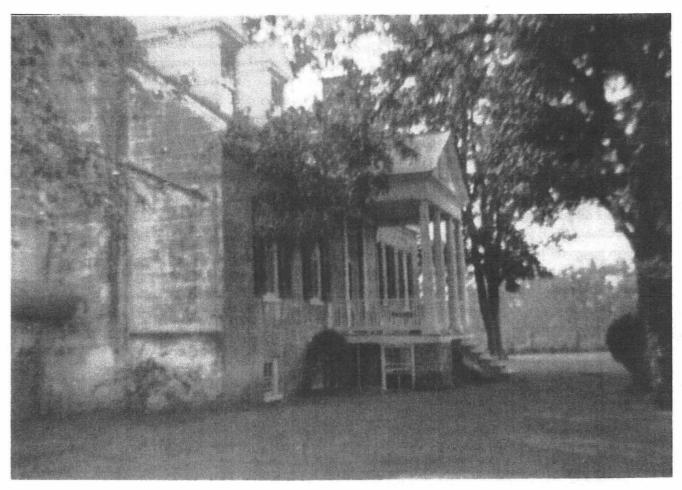
Figure 1.25 This undated image shows the evidence of the point of attachment of the east wing constructed by Watson Pendleton Jordan and removed prior to 1900.

The Jordans (who purchased the property in 1838) apparently added an east wing, which was removed prior to 1900. The current east wing contains a powder room and bath and an exterior access. The west side kitchen wing was added around 1980.

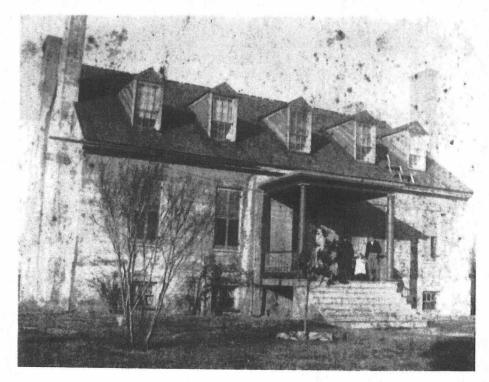
Figure 1.26 The earliest known image of Windsor Castle, this photograph was taken circa 1910. Note the newly planted magnolia to the left of the stair. It appears from the roof ladder and projecting gutter, that the house was under repair at this time

c. 1910	Earliest known photograph (may be earlier) shows diagonal boards on dormers, wood shingle roof, closed louvered shutters, outline of flat arch above windows, dark painted porch posts and cornice, white pickets, curtains on basement windows, light painted sash, very small magnolia, steps on roof, partial gutter

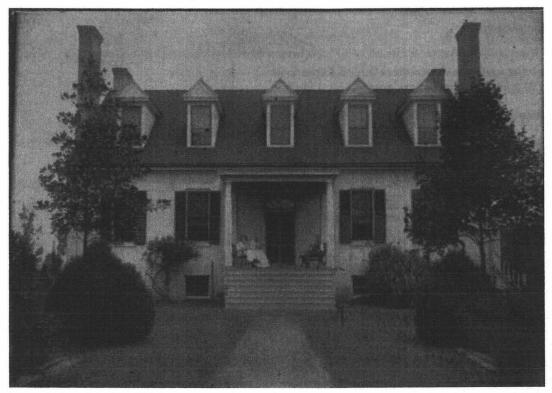
Figure 1.27 This circa 1915 image shows the repairs underway five years earlier have been completed, and include new dormers, a fresh coat of stucco with scoring, and a new paint scheme. Note the stair extending from the right side of the house.

c. 1915	Photograph showing Jeremiah Johnson and wife on porch after rehabilitation of house
	Shows reworked dormers with higher pitch to dormer roof, horizontal German siding on sides, dark painted sash
	Stucco has been repainted and scored, flat arch shadow disappears, replaced with smaller lintel, open louvered shutters, boxwood and more mature magnolia trees, all sash dark, porch painted white
1917	Jeremiah Johnson sells property to son-in-law Charles Betts
	Lease between C. S. Betts and J. W. Savedge for farmland
	Land to be planted in Irish potatoes, garden peas, watermelons, sweet potatoes, oats, peanuts, corn, and soybeans and black peas for the hogs
	Hogs to be raised on land and cared for by Savedge with profits split
	Provides for maintenance of fences, storage and shipment of crops, etc.

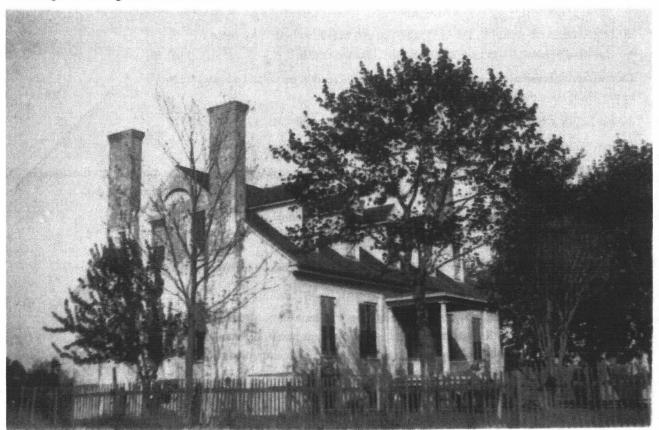
Figure 1.28 By 1925, there was a picket fence surrounding the house. Note that the stucco has begun to age and the magnolias planted circa 1910 are quite large.

c. 1925	Photograph - wood shingle roof, dark sash, picket fence around house, stucco beginning to discolor
